Breakthrough: Gel Clear reduces maintenance costs

A recent Sauermann Australasia Gel Clear tablet trial was conducted at a store located in Sydney, NSW. The store has a problematic history of water leaks on the store trading floor.

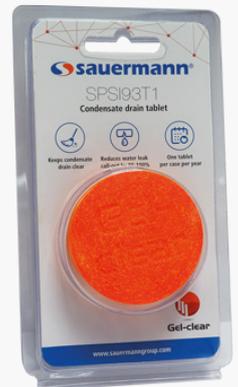
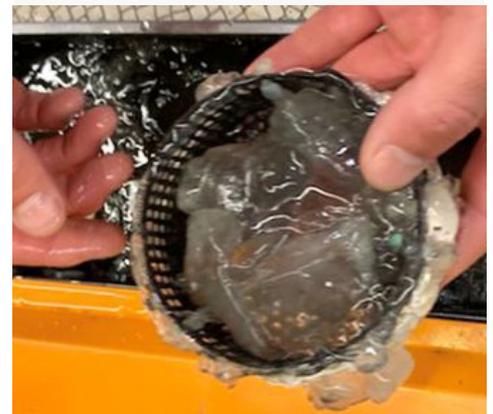
If the refrigerated case and condensate pump was not proactively cleaned, this biofilm evolved into thick sludge

Each of the condensate pumps at the store regularly formed biofilms stemming from their respective refrigerated case. This was most evident in the dairy section, but was also problematic in the produce, bakery and meat sections. If the refrigerated case and subsequent condensate pump was not proactively cleaned, this biofilm evolved into thick sludge.

The sludge caused the condensate pumps to block, stop operating and resulted in water leaks. In some instances, the pumps failed completely requiring replacement. Over time the condensate discharge lines between the pumps and tundishes started blocking up, requiring replacement, incurring additional labour cost and downtime.

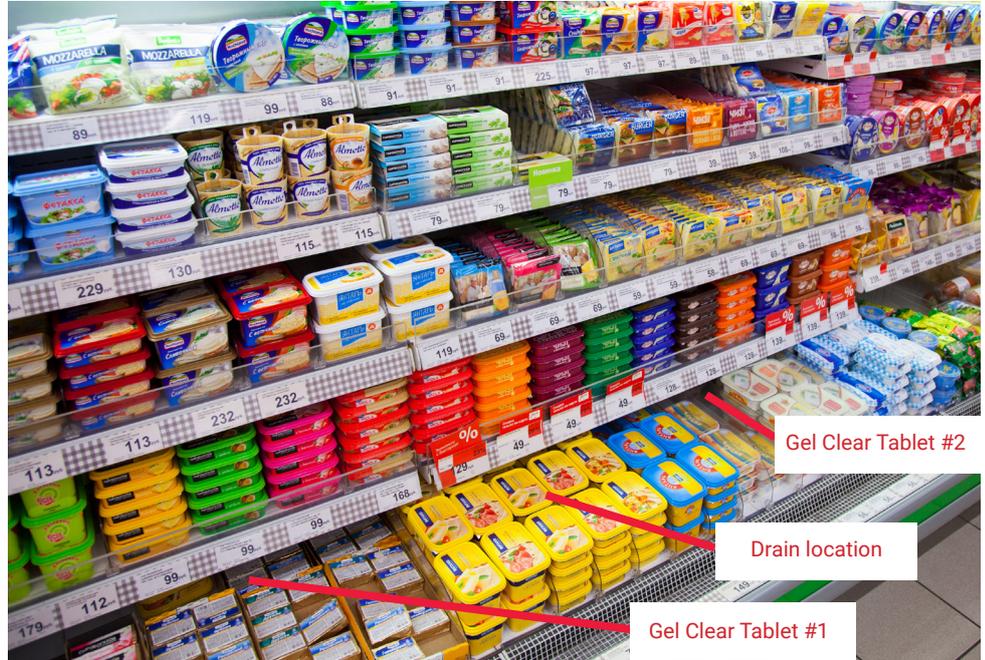
The customer was shown the correct way to install the product for these cases i.e Install 1 x Gel Clear tablet on the high end of either side of drain entry point. This allowed the tablet to slowly dissolve and coat the condensation path.

Method: In January 2019, the base trays of the nominated refrigerated cases were unloaded to access the drain pan. Note: Even though these cases received a full clean a couple weeks earlier along with discharge hose replacement, a thin layer of biofilm was already starting to form in the pump.

The customer was shown the correct way to install the product for these cases i.e Install 1 x Gel Clear tablet on the high end of either side of drain entry point. This allowed the tablet to slowly dissolve and coat the condensation path.

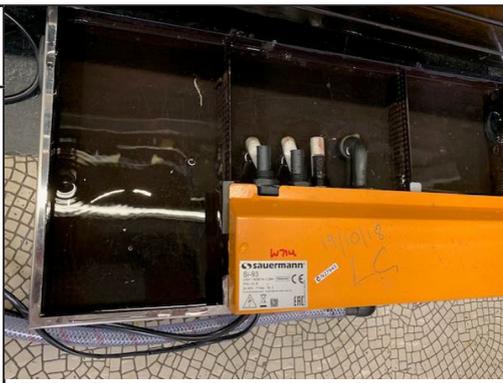
<p>3mth inspection results Gel Clear</p> <p>No reported water leaks No biofilm forming No new tablets installed Inspection to be conducted again at 6 months</p>

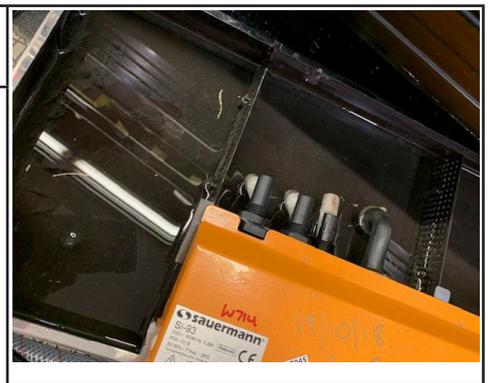
<p>6mth inspection results Gel Clear</p> <p>1 reported leak on 29/07/2019 in dairy case 1 No other cases leaking Thin layer biofilms starting to form in case & pumps</p>

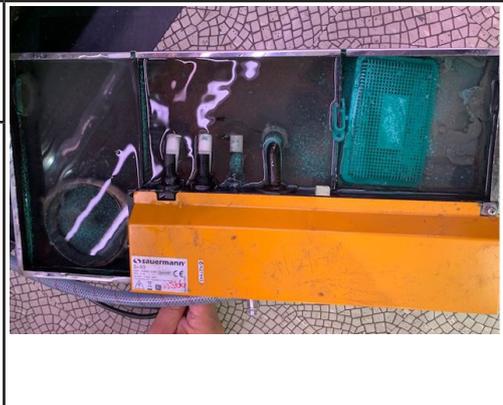
<p>3mth inspection results competitor product</p> <p>Biofilms forming Pumps blocking required to be cleaned</p>

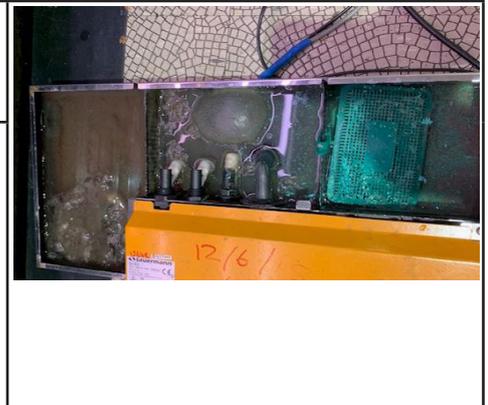
<p>6mth inspection results competitor product</p> <p>Biofilms still forming Pumps blocked</p>
